## De Tomaso of America

THE FOLLOWING MODIFICATIONS HAVE PROVEN TO HELP SOME OF THE GROWING PAINS FROM WHICH THE PANTERA SUFFERS.

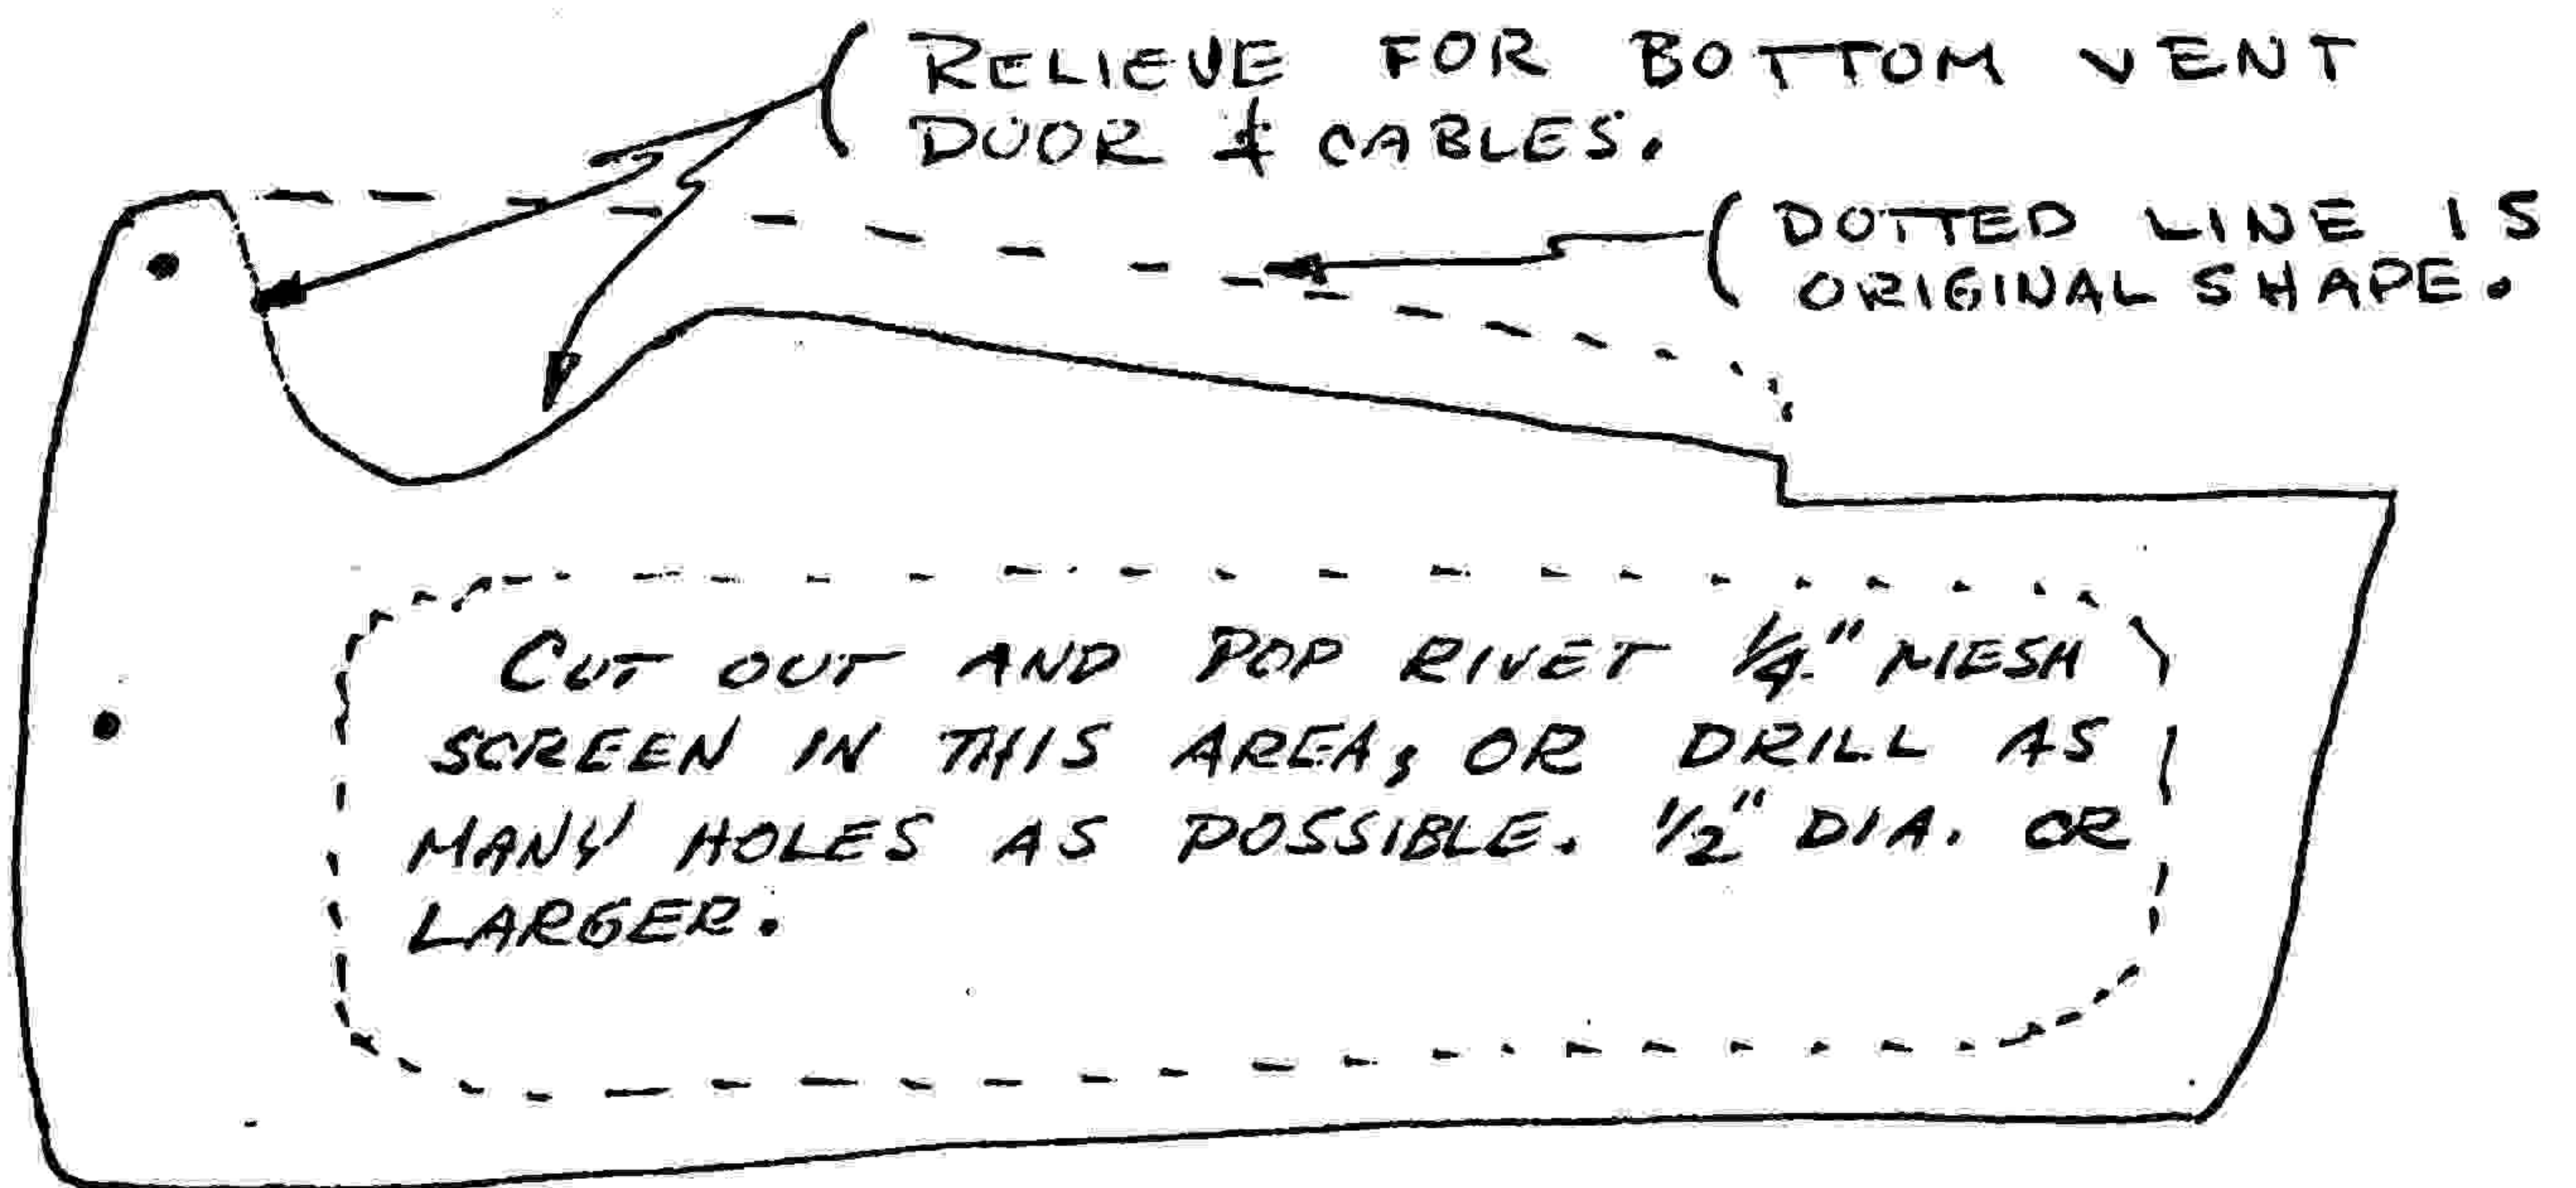
R.H. KICK PANEL

① BOTTOM VENT DOOR IS 90% ENCLOSED WITHIN CONSOLE KICK PANELS AND RESTRICTED TO 50% OF BEING FULLY OPEN BECAUSE OF CONTACT WITH TOP EDGE OF R/H KICK PANEL. THEREFORE THE TWO UPPER DASH VENT DOORS ALSO DO NOT OPEN FULLY AS UPPER & LOWER VENT DOORS OPERATE FROM A COMMON BELL CRANK.

REMOVE BOTH KICK PANELS AND  
MODIFY AS PER DIAGRAM.

MODIFYING THESE PANELS INCREASES AIR CIRCULATION BY NO LESS THAN 50%.

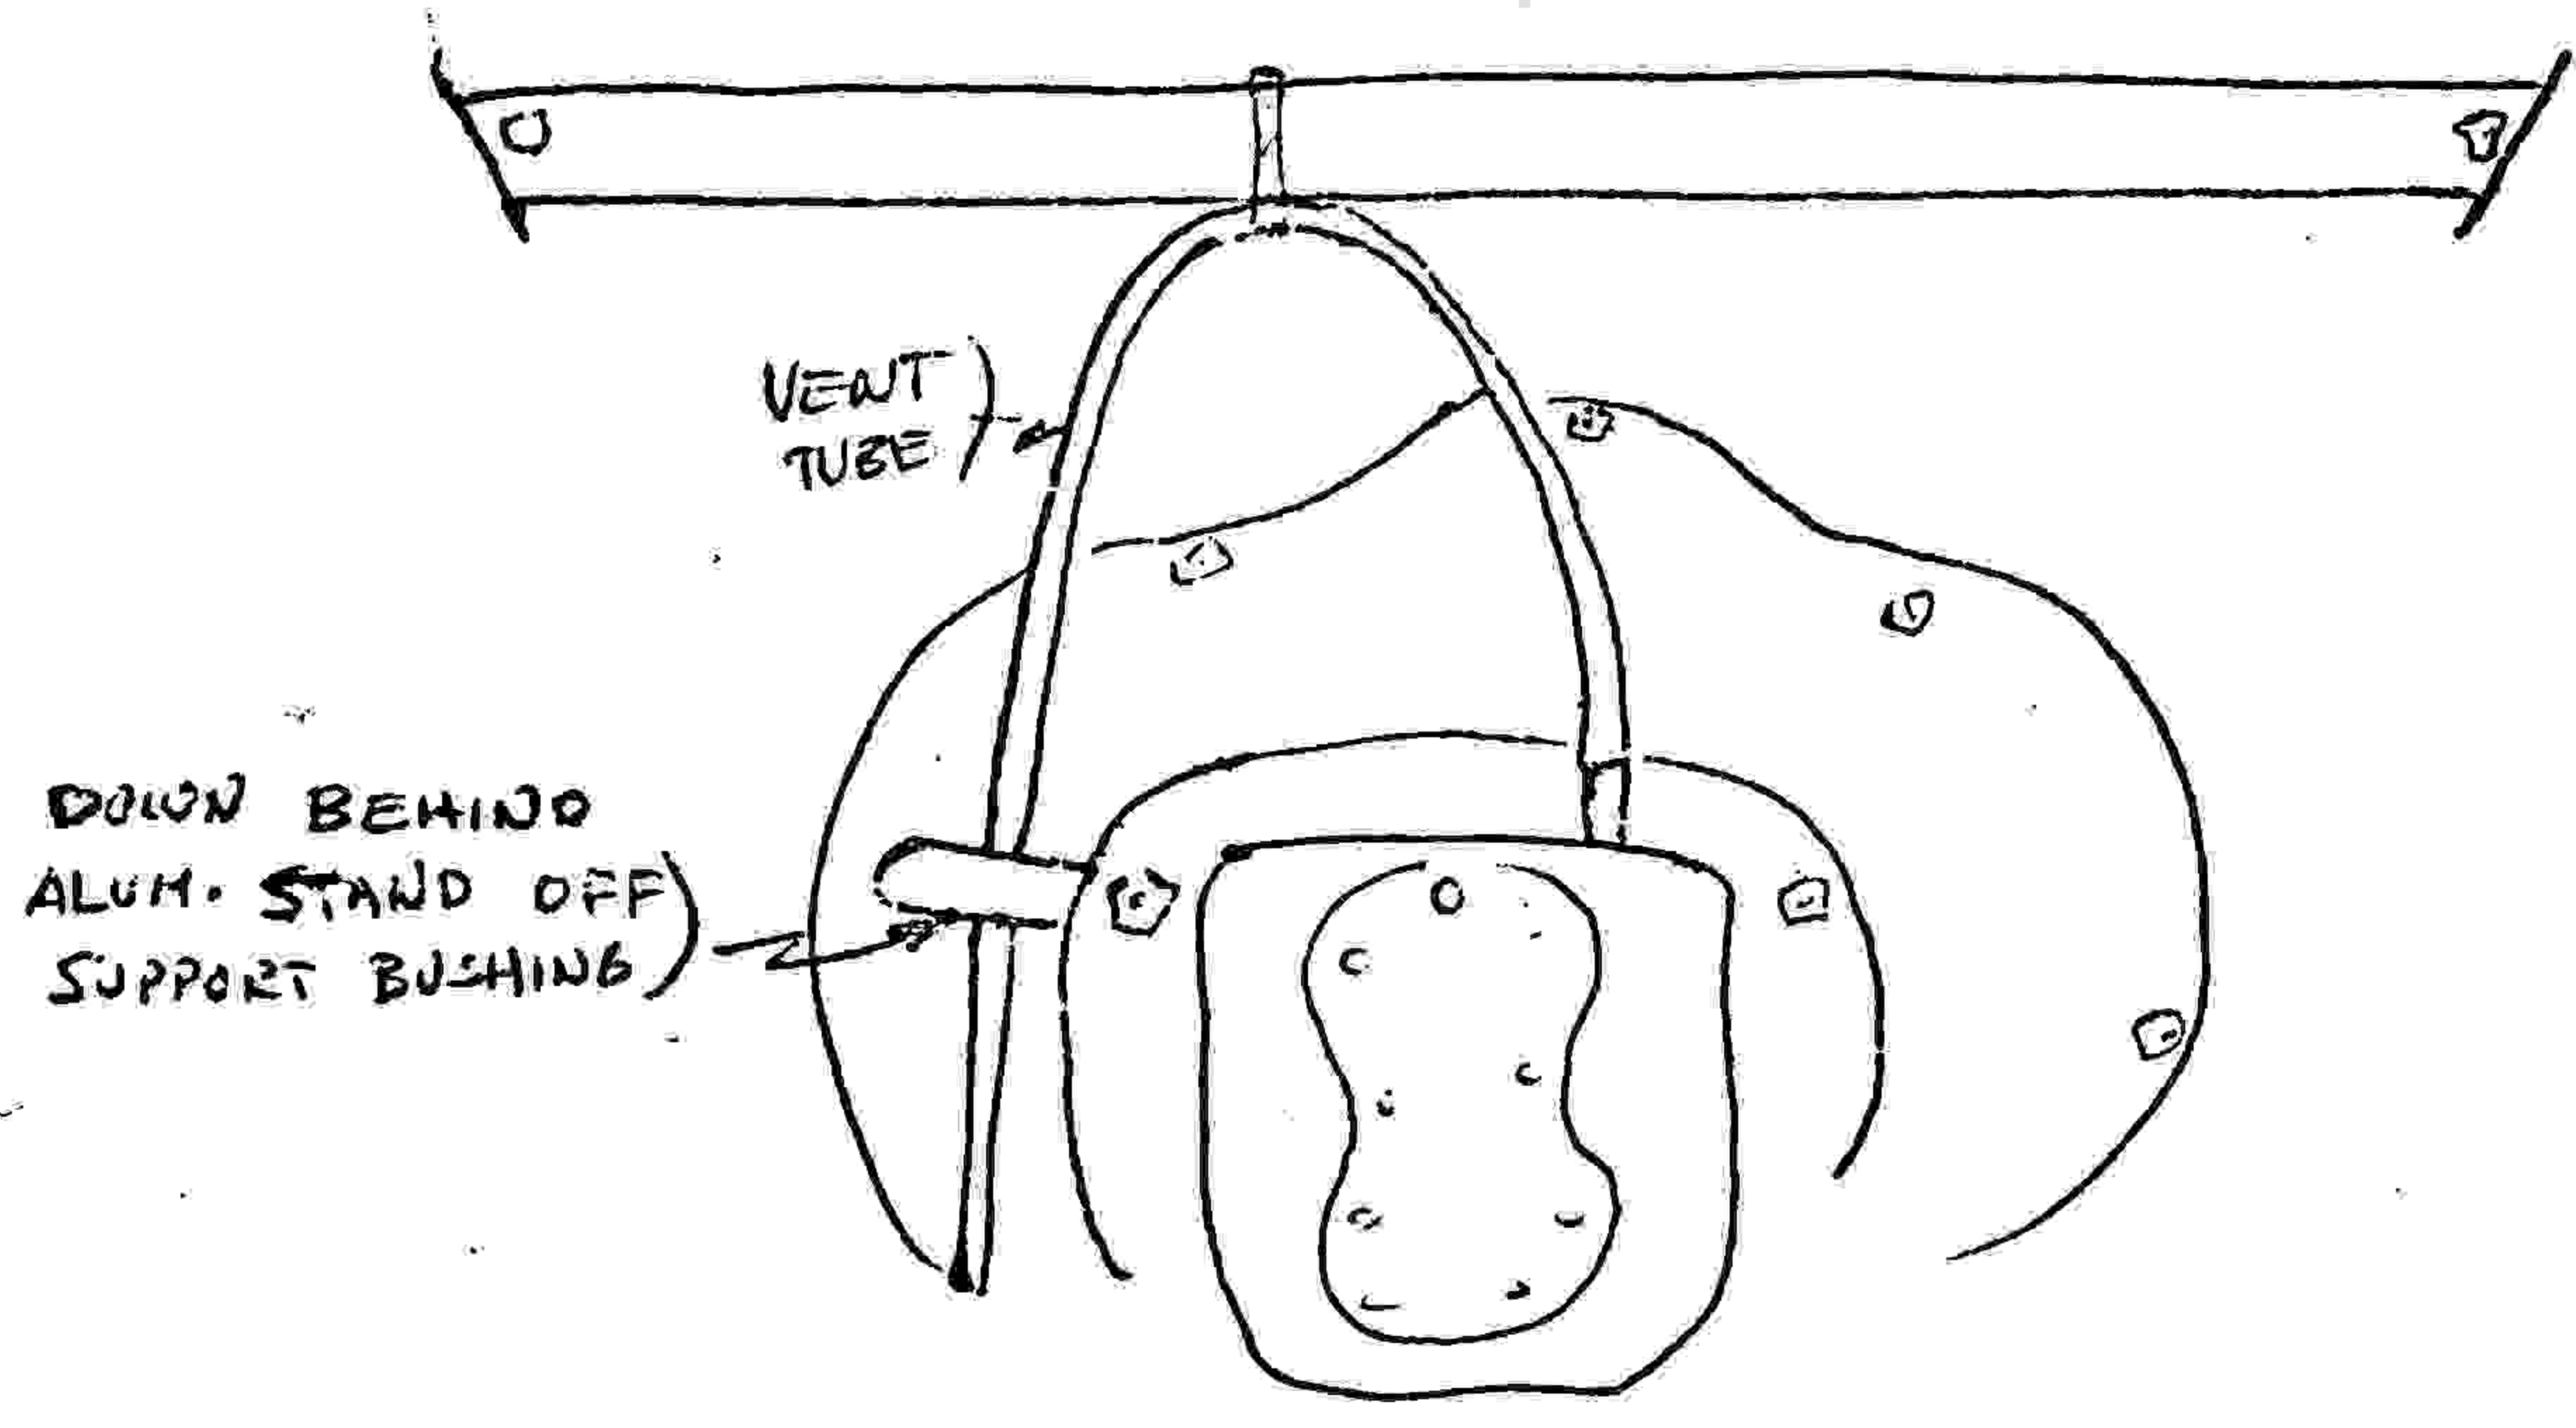
SMOKE FROM LEFT REAR AREA IS CAUSED BY TRANSAXLE BREATHER TUBE BEING ROUTED OUT LEFT SIDE BODY PANEL DIRECTLY OVER L/H HEADER.

EXCESS OIL DRIPPING COMES PARTLY FROM HERE, TOO. SMALL CATCH BOTTLE COULD BE INSTALLED.

REROUTE THUSLY —
